Lester Guard Station, Warehouse/Storehouse
(Gas and Oil House, Bldg. No. 2532)
Forest Service Road No. 45
Lester
King County
Washington

HABS No. WA-172D

UNITED STATES DEPARTMENT OF THE INTERIOR
NATIONAL PARK SERVICE
HISTORIC AMERICAN BUILDINGS SURVEY
ARCHITECTURAL DATA FORM

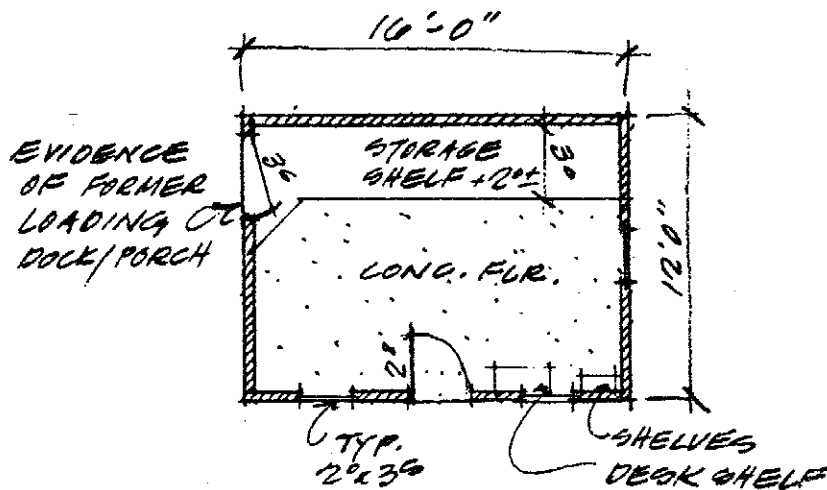
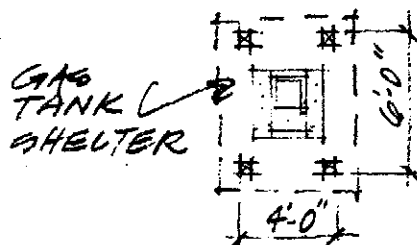
HABS No. WA-172D (page 3)

GAS AND OIL HOUSE (BLOG#2532)

LESTER GUARD STATION
KING COUNTY
LESTER, WASHINGTON

NOTE: PAINT IS
BROWN OCHRE & RED.
ROOF: BLUE
